**Report of Overview Condition Survey for Valuation Purposes**  
**Sailing Vessel**  
**“GOLEM”**

<b>Client:</b>	Wilsons Auctions
<b>Hull identification/build number</b>	Hull 343
<b>Description of Vessel:</b>	Aluminium Alloy Sailing Cutter
<b>Type/Builder:</b>	Nordia 57/Hull Gouwerok/ Outfit Nordia van Dam
<b>Stated Year of Build/Flag State:</b>	Hull 1987/Completion 1990/NA
<b>Registered Tonnage/Port/ number:</b>	NA/9392ZA1994/Muiderzand
<b>Recreational Craft Directive Plate:</b>	NA
<b>Approximate Dimensions:</b>	LOA:17.20 (m); BOA:4.44 (m) Draft:2.13 (m) Displacement: 28,000 kg
<b>Propulsion:</b>	Single six cylinder diesel with conventional shaft drive
<b>BPML Surveyor:</b>	Richard Linford BSc, MSc, CEng, CMarEng, MIET, MIMarEST AMYDSA
<b>Contract number:</b>	BPML 931-16
<b>Location / Conditions for Survey:</b>	Richbrough Kent/Out-of -water
<b>Dates of Survey:</b>	20 <sup>th</sup> June 2016

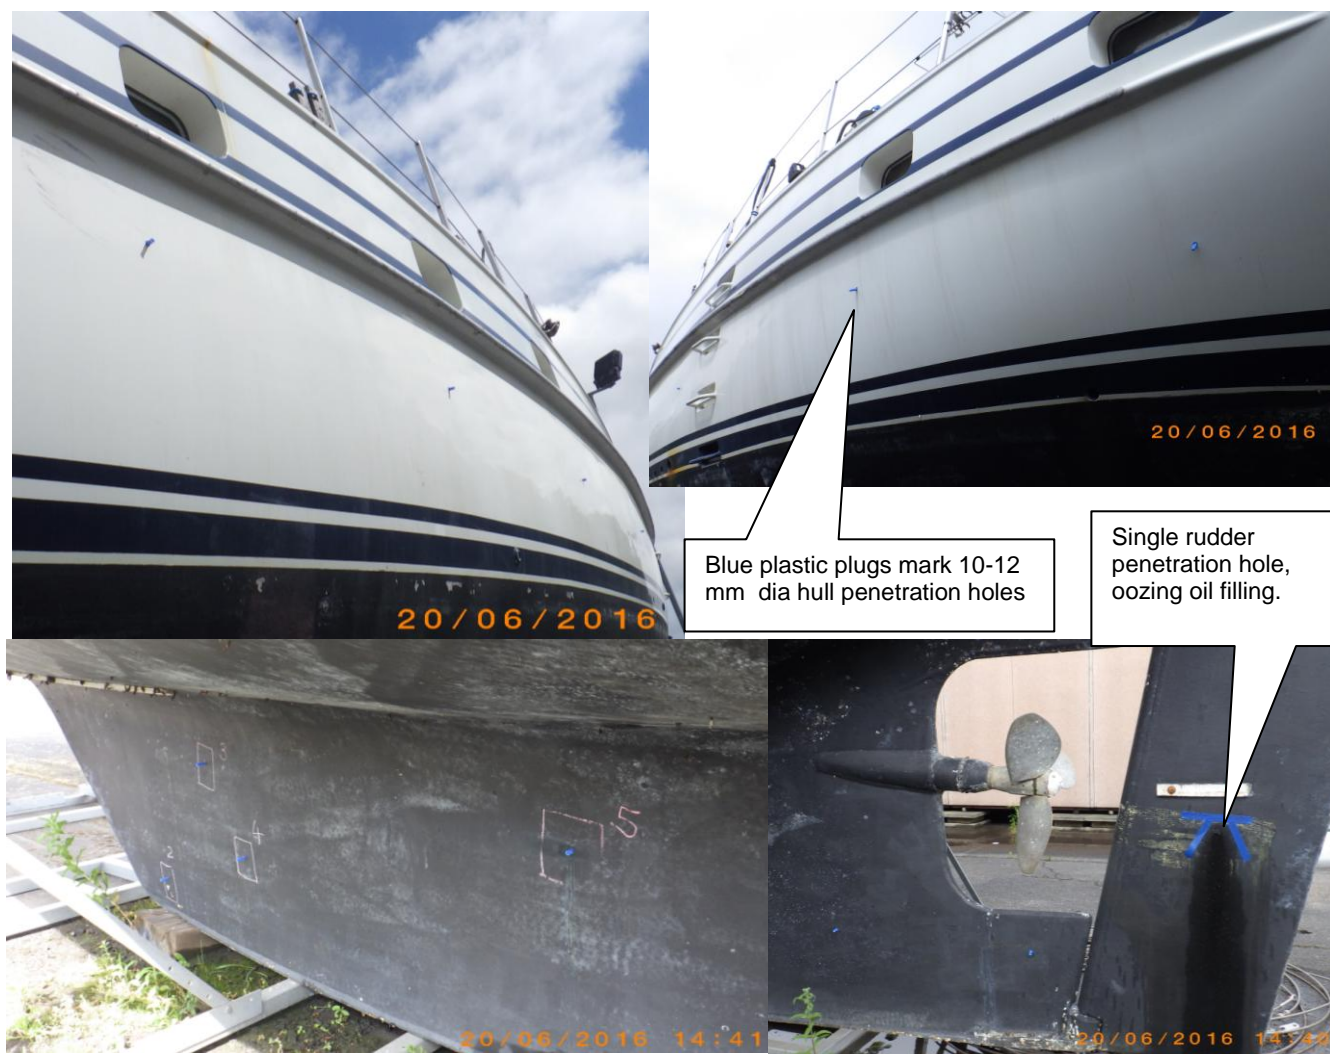
The hull topsides, keel, rudder and skeg areas have had penetrating holes drilled through the alloy skin [see pictures below]; these are approximately 10-12 mm diameter and clean. There were 17 holes seen on the port side with just one on the starboard. There may also be holes drilled in the underside of the keel but these could not be inspected due to lack of access; this area should be inspected and verified.

Overall the external hull shell plate is in good condition with no evidence of significant damage, repair, pitting or corrosion seen; accept for the holes described above.

The substantial skeg mounted box rudder is secure with minimal bearing wear. The rudder void appears to be oil filled; there is a hole [10-12mm dia] drilled in the port side with a rag plug which is oozing oil as per picture below. This hole should be repaired as per the hull holes.

This hole damage must be rectified via suitable plug or insert welds before the vessel can be launched. Such repairs should be undertaken by a fully coded weld contractor with certification and current experience in vessel shell plate repair in Aluminium alloy. The upper & lower topside holes should be accessed internally to remove any internal insulation or flammable material prior to hot work.

Hole repairs to the topsides will require local fairing and paint system matching to restore the otherwise generally good order finish.

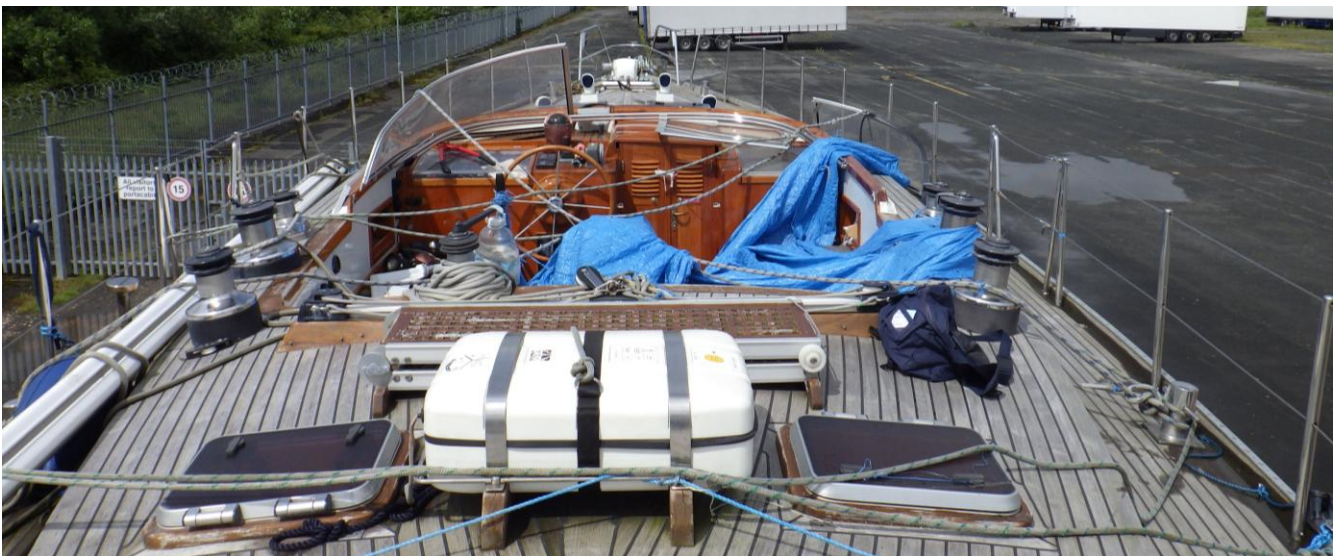
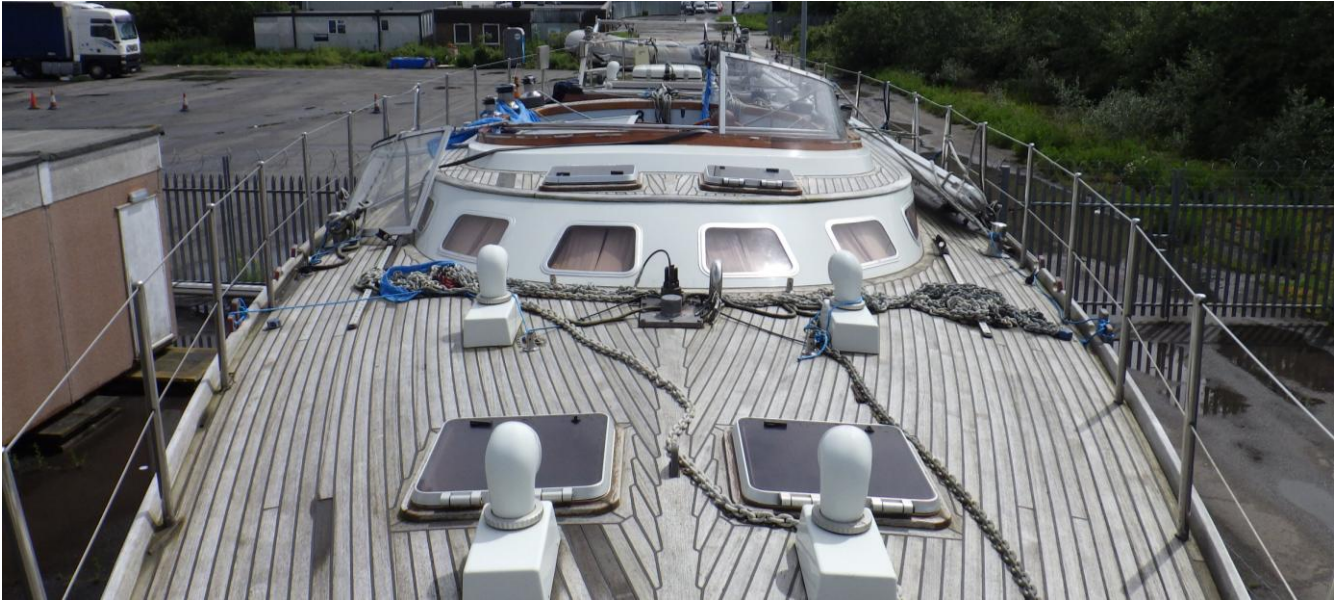
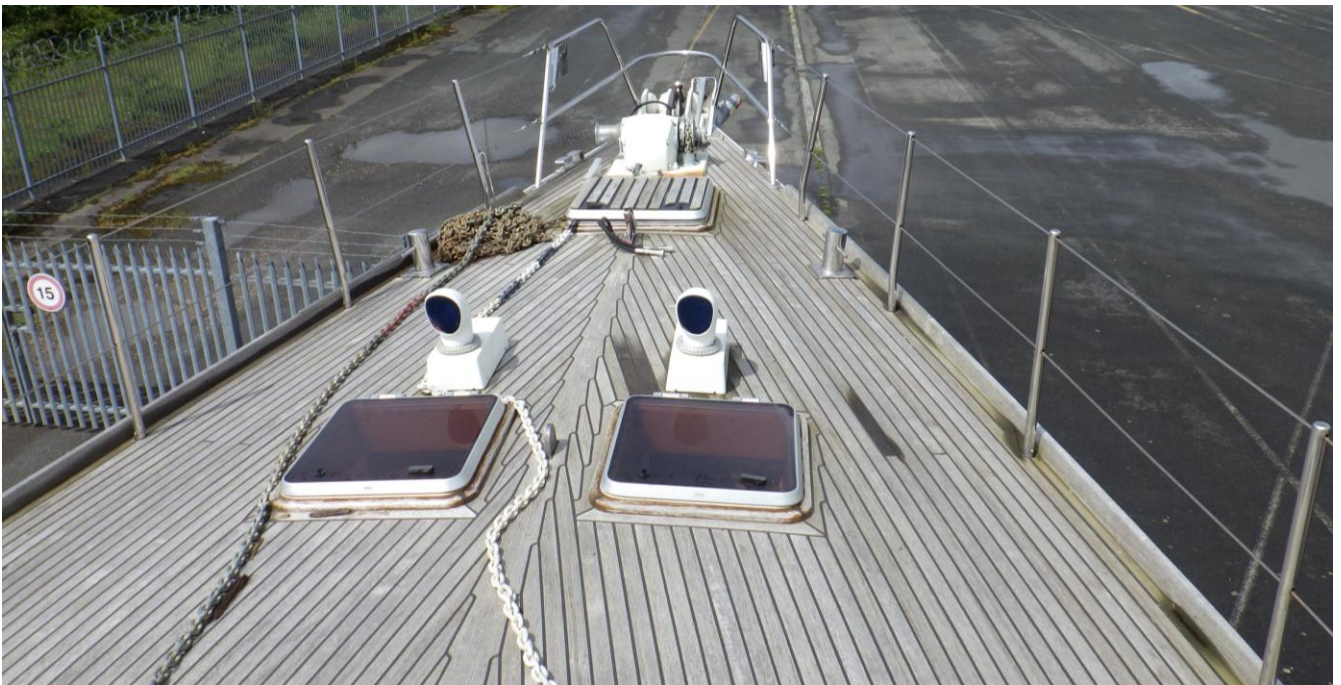
Swept teak cladding over all decks, in generally good serviceable condition with no major defects or damage seen; would benefit from a light clean [but never a pressure wash].

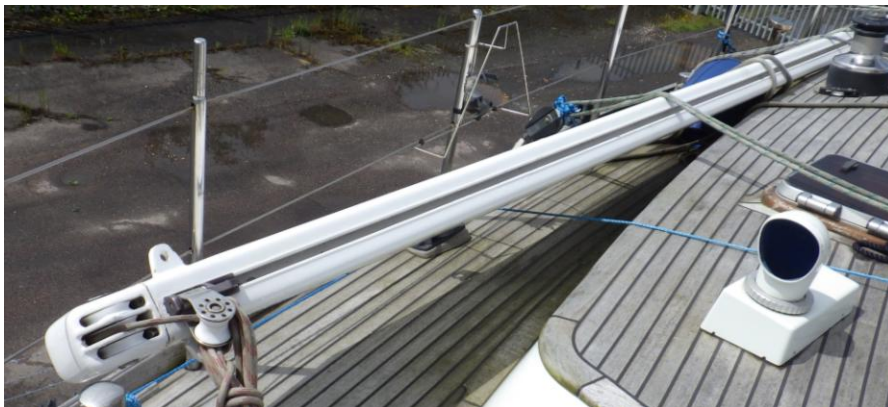
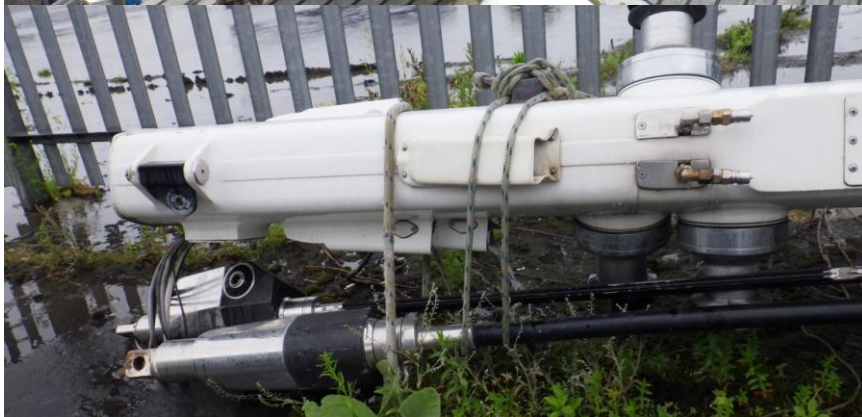
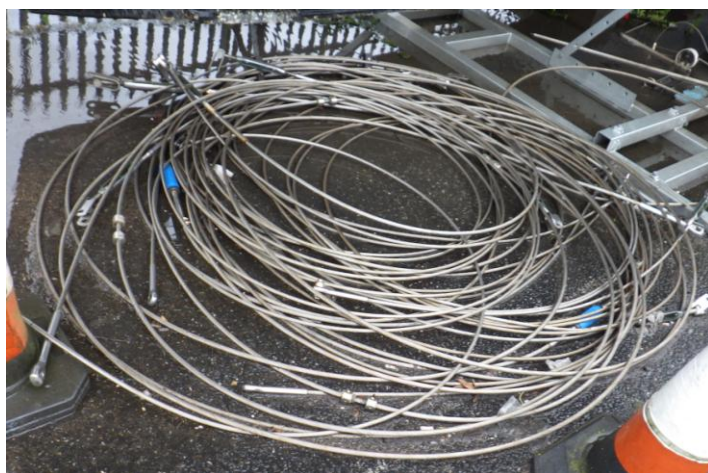
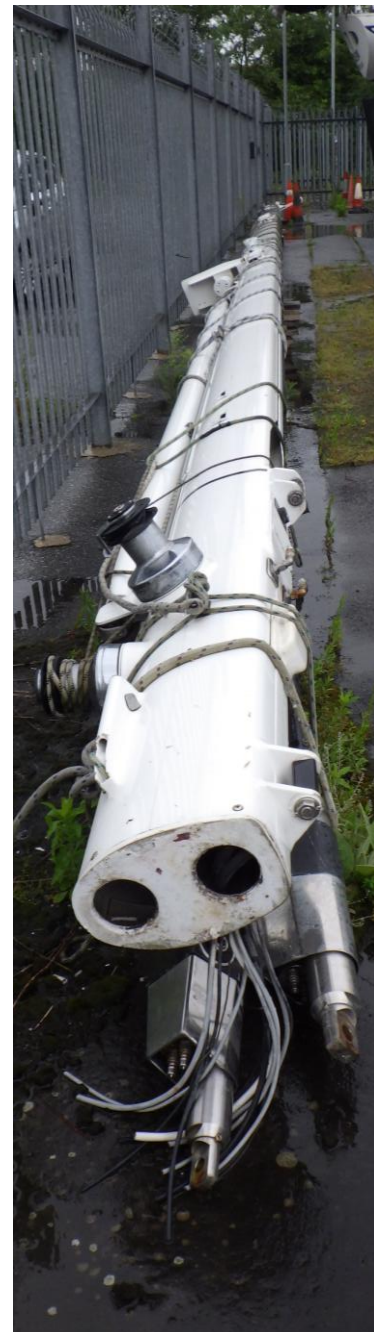
The mast has been removed from vessel and is lying nearby. This white painted double spreader Aluminium deck stepped mast is robust and in generally good order with no significant damage, distortion or repair seen. A spinnaker pole is also attached to the mast in similar order.

The boom is laying long the port deck and is also in serviceable order.

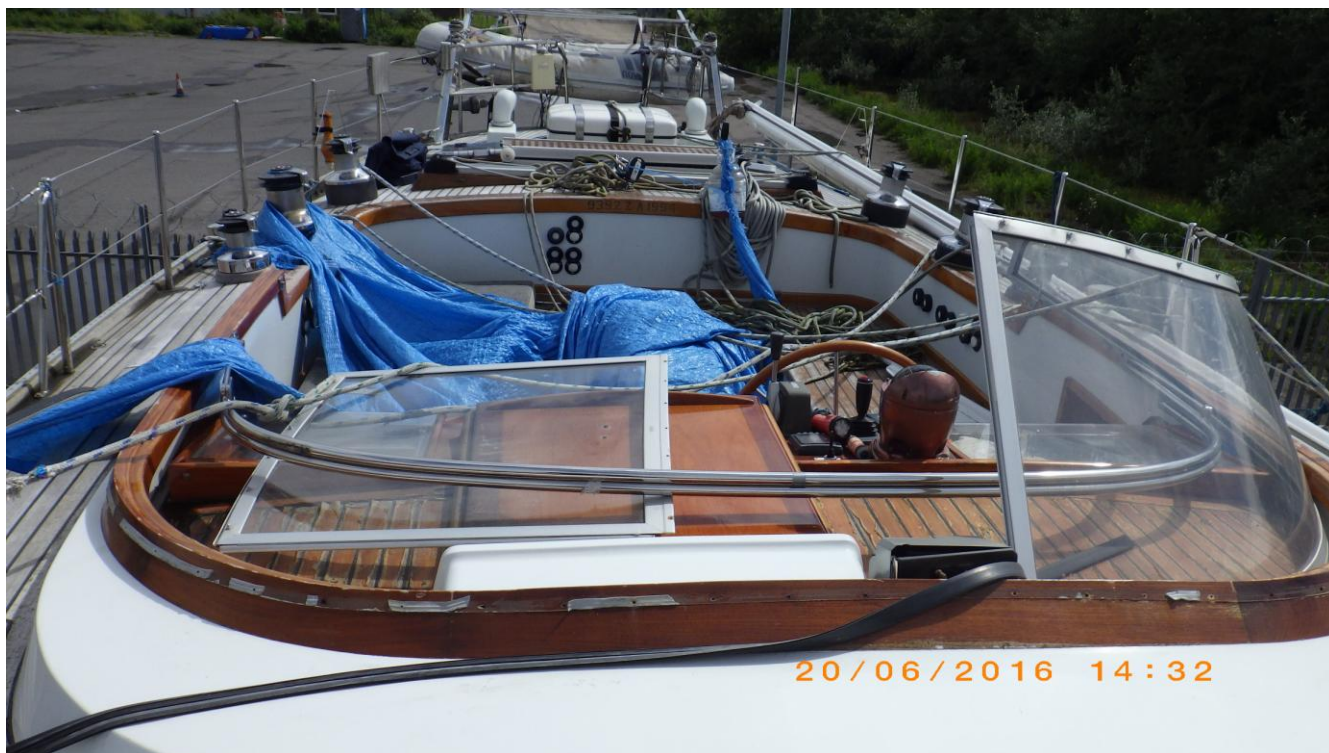
Substantial range of manual and powered Lewmar self-tailing winches including two off Lewmar 66 electric genoa winches; all appeared in serviceable order.

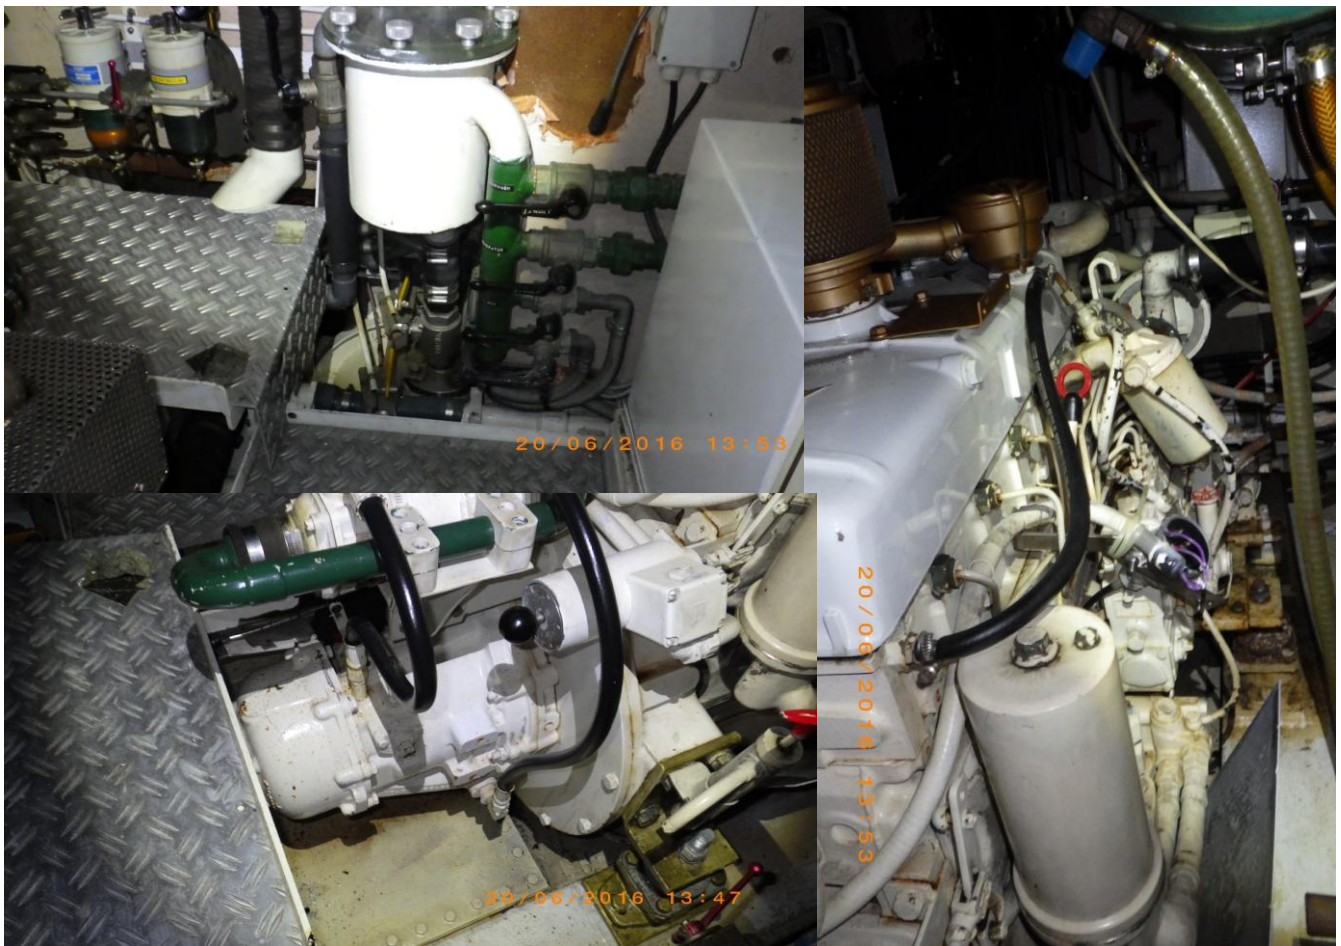
A single Mercedes OM352 6 cylinder naturally aspirated direct injection 4 stroke diesel engine. This is a well-known mechanically controlled engine with good reliability record going back to its origins in the early 60's and before. Whilst no longer in production, due to emissions regulations, most spares for this engine should be available. The engine has a hydraulic pump, which operates the bow thruster and anchor winch.

The engine looks to be largely undisturbed with oil to correct level and no obvious indications that it would not continue to give service, provided it is carefully checked over and service prior to operation.

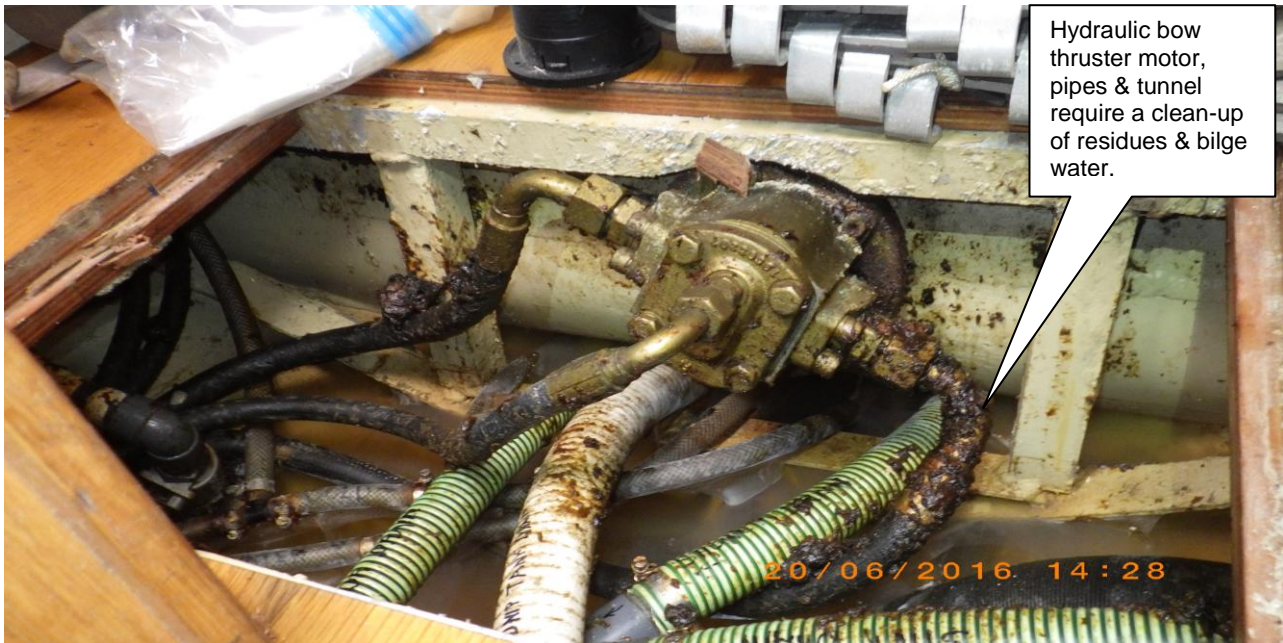
The bow thruster is a hydraulic driven unit. The hydraulic motor and thruster tunnel were inspected internally & externally and all appears to be in order except that the internal motor and pipework need a clean off of residues. See picture below.
